**Hugo Lake**  
**Discussion**  
October 25, 2023  
Oklahoma State Capitol

# Hugo Lake Assessment (Feb. 2023)

# Hugo Lake Assessment (Oct. 2023)

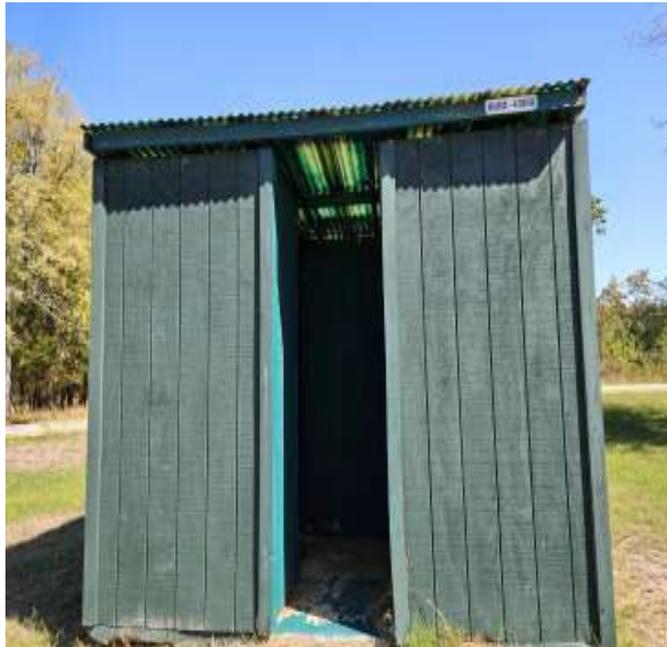
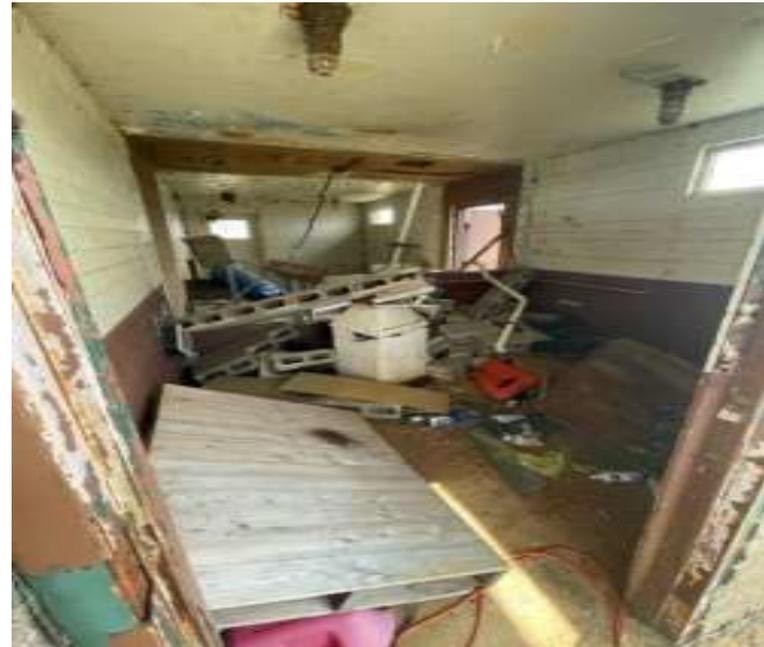
# Restrooms

All restrooms are in disrepair or non-working. It was discussed to remove two of the vault style units as they are in areas that do not benefit from having them. The marina restroom structure remains dilapidated and poses health and safety risks to the park. The structure falls in the flood plain of the lake. It is advised to demo this unit and relocate to a better location

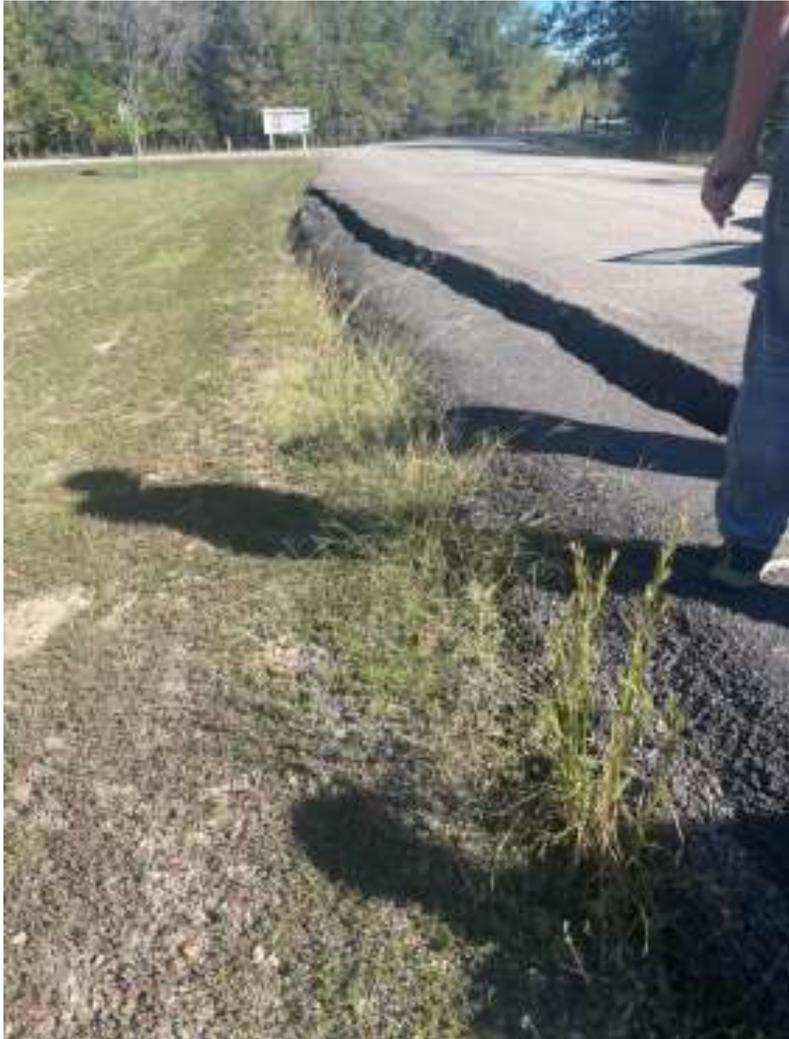
# Park Roads

**Paving** - The roadway in the park is in a severe state of disrepair. It was observed that road conditions have degraded from OTRD's original visit in February 2023.

OTRD spoke with Anthony Eschelle, an ODOT engineer, who has completed a surface inspection of roadways throughout the park. He identified that the work and material was beyond inadequate at the time of installation. All roads throughout the park are critical with some sections worse than others, nearly unpassable. He believes the deterioration to these roads is caused by the shrinking and swelling of the subgrade.

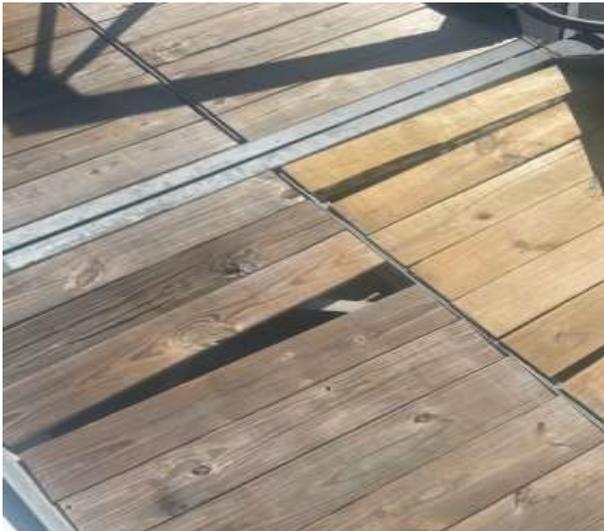
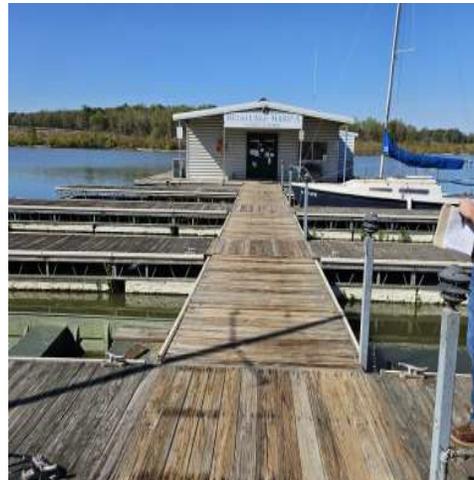
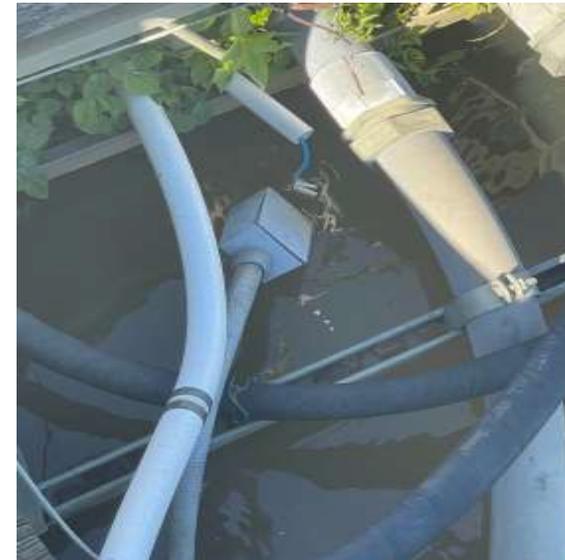
# Marina

The park continues to office out of the marina as there is currently no structures suitable for an administrative center. The marina will need a full inspection as current conditions are not suitable for use and pose serious risks and liabilities. Electrical deficiencies and ADA violations are of major concern. The entire length of boardwalk was at some time replaced with new wood. These planks were never secured to the walkway leaving large gaps between them. Most floats were encapsulated foam-filled with some remaining unencapsulated polystyrene. Unfortunately, several encapsulated floats have been compromised due to deterioration

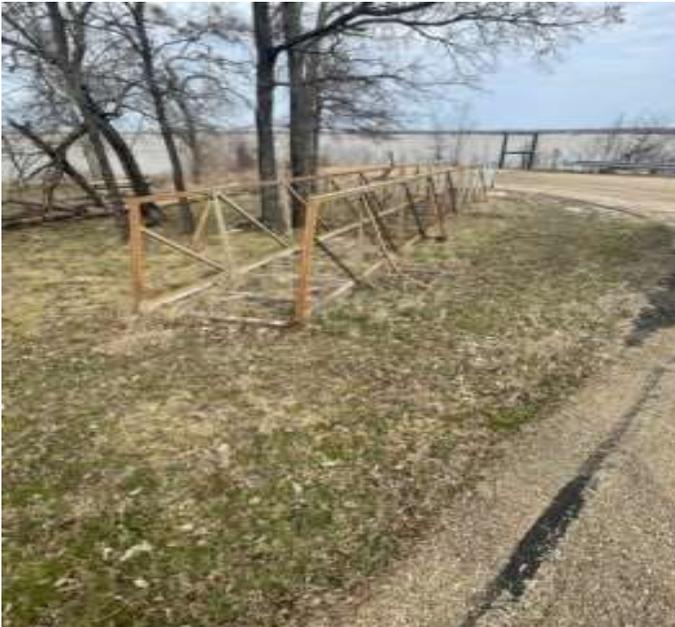
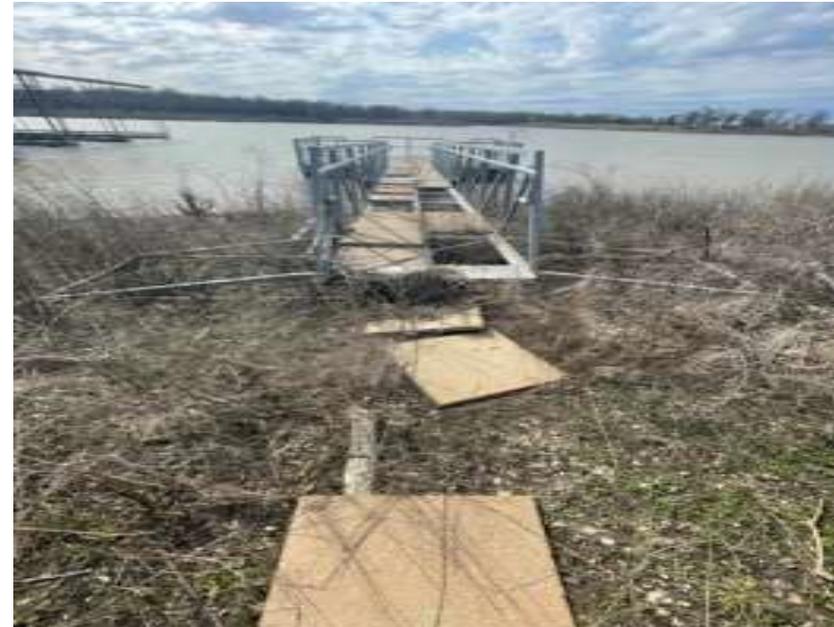
# Docks

Two floating docks, both are inoperable. These will need to be replaced or repaired

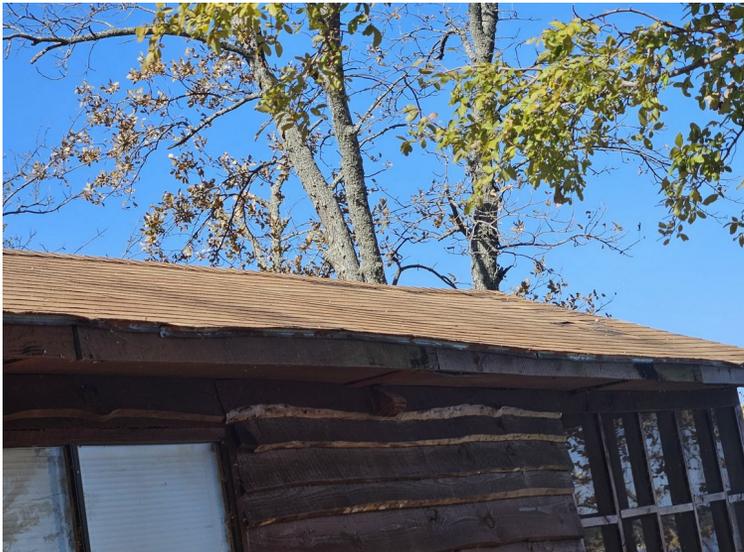
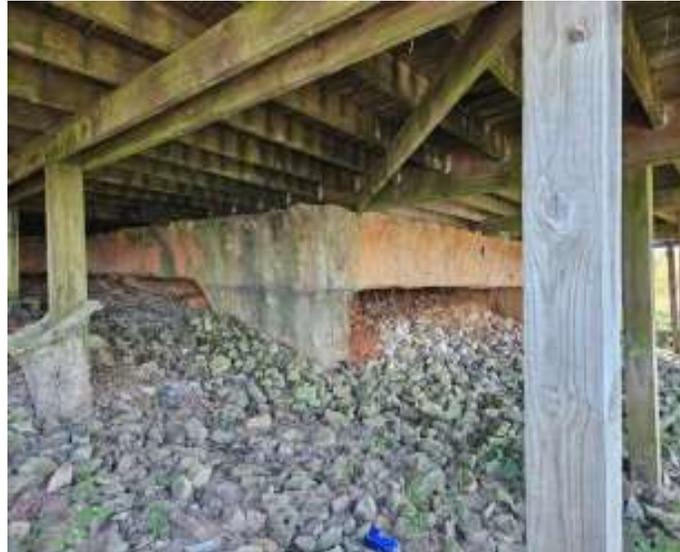
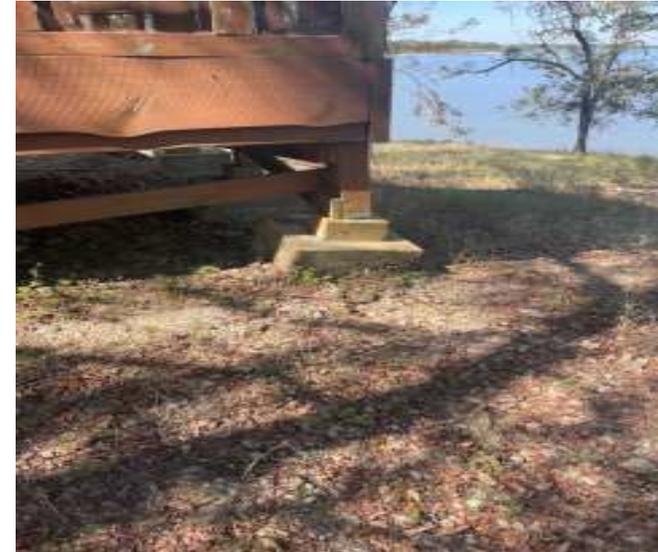
# Cabins

The exterior of cabins look to be well kept. Several roofs will need to be replaced as they are failing due to wind and water damages. Major concerns currently include severe undermining and shifting pier foundations. All decking and railing will need to be thoroughly inspected and replaced as needed as some components have aged and weakened over time.

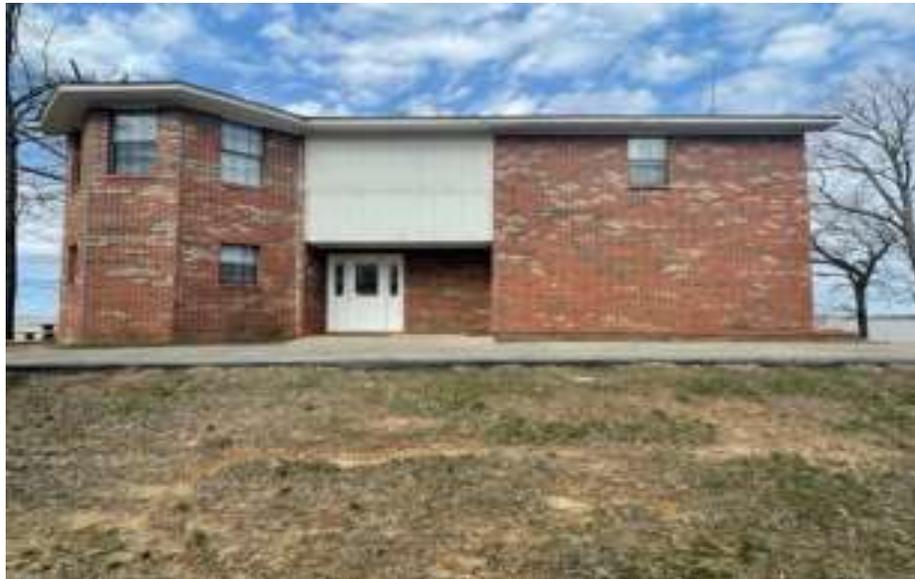
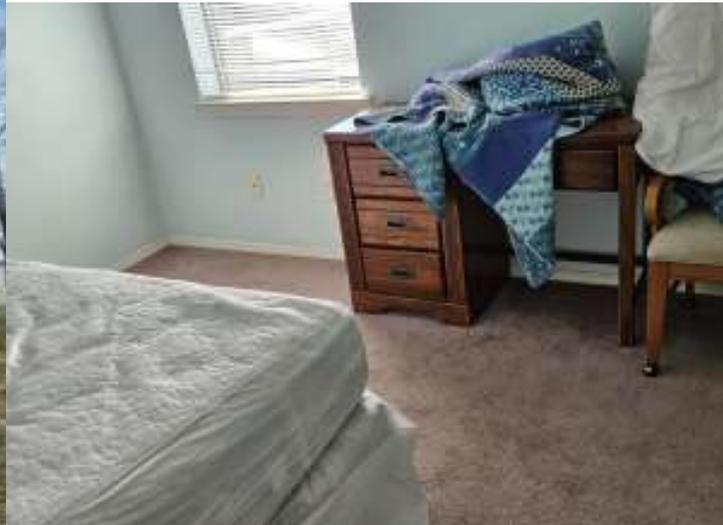
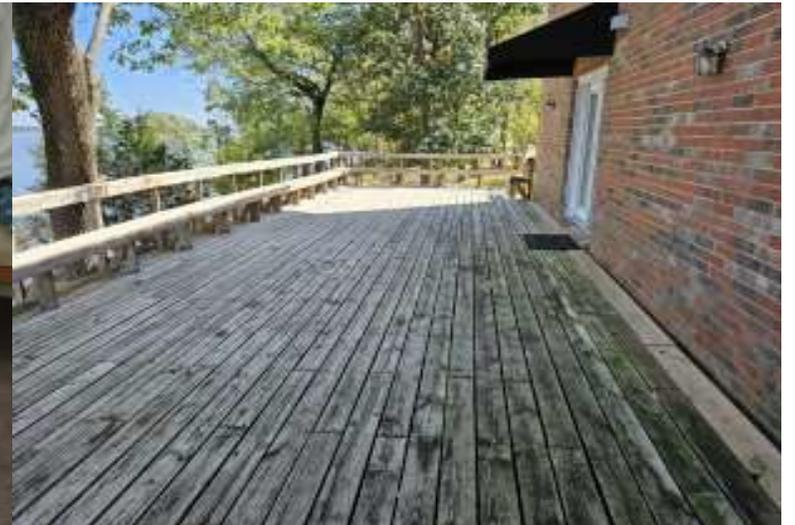
# Community Center

The Community Center appears to be in sound condition. Mechanical, electrical, and plumbing were not inspected but looked to be in working order. A full interior remodel would be advised as interior finishes are well used and beyond their life expectancy. This would also allow for a space that is more useable and functional than the existing layout

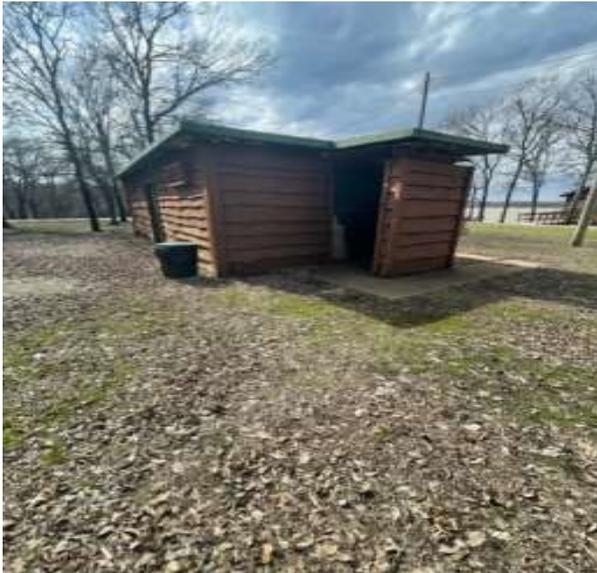
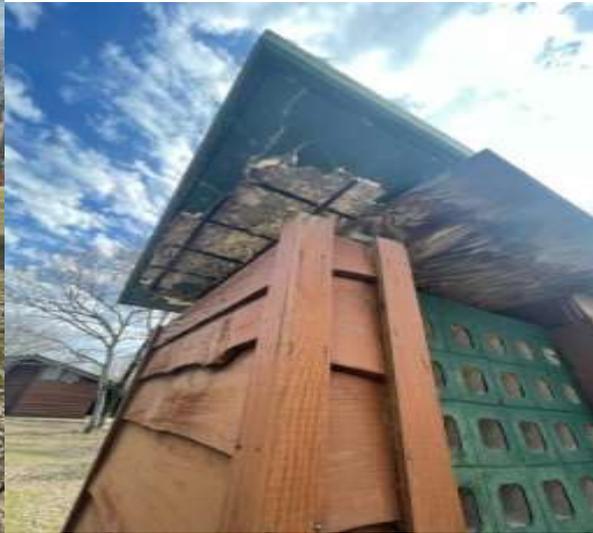
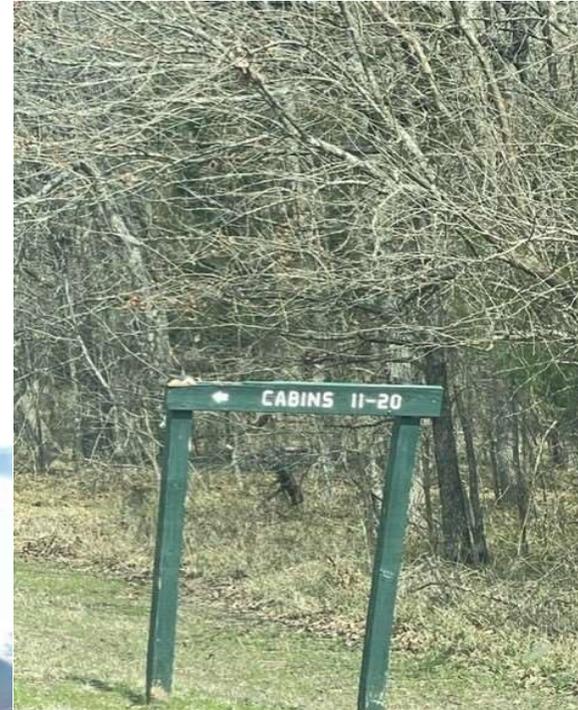
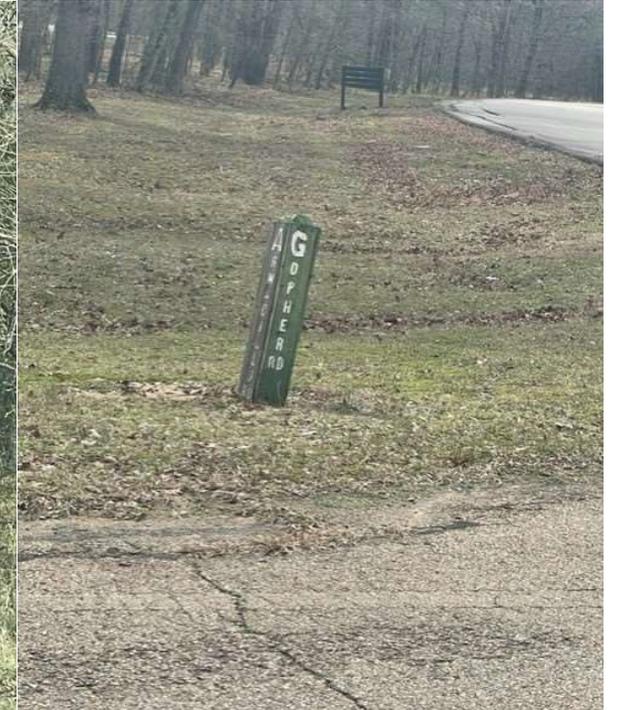
# Park Kitchen and Signage

**Kitchen** - Unable to determine condition of kitchen. This kitchen was remodeled from a vault toilet. Concrete roof is in very poor condition

**Signage** - Most of the park is lacking clear and concise signage throughout. The signs that remain are showing age and wear from the elements
